**Flood Control Project Maintenance
Levee Inspections**

Fall 2016 Levee Maintenance Deficiency Summary Report

Reclamation District No. 0551 Pearson

Levee Inspection Report By Mile - Fall 2016

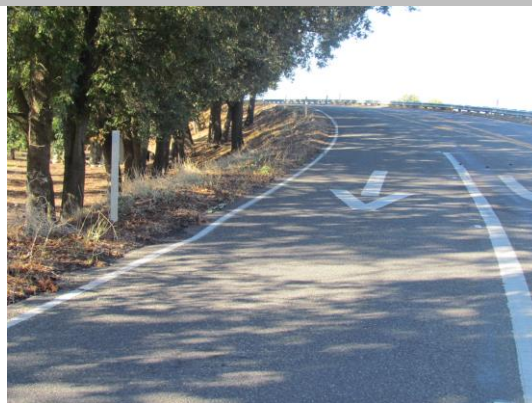
Photo 1 of 1 : FA_2016_RD0551_175_18_20161101_00038.jpg

LM Start	0.03	Rating **	A	Issue No.	18
LM End	6.78	Issue Type +	Ma	Location *	LS
Category	Earthen Levee			GPS Latitude/Longitude	
				Start	End
Item	Vegetation			38.336123 °	38.258886 °
				-121.565020 °	-121.517901 °
DWR ID	DWR_RD0551_01_f_2016_18				
Comment Code					
V1 : Control annual grass and weeds on the levee slopes and easements.					
Inspector Comment					
The goats has gone throughout the District both landside and waterside slopes has been maintained from levee 0.03- to 6.78. Good job on vegetation removal.

RD 551 Looking downstream from levee mile 0.03 landside slope.

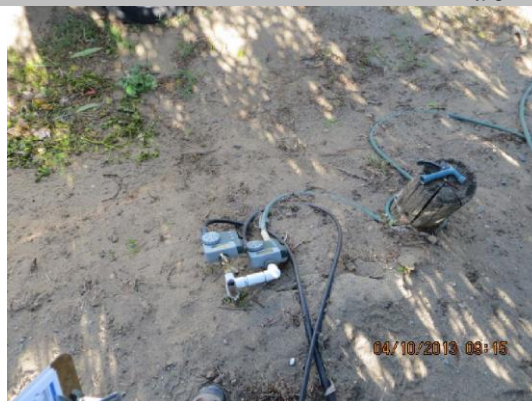
Photo 1 of 2 : UCIP_FA_2016_11705_19145.jpg

LM Start	0.41	Rating **	M	Issue No.	94
LM End	0.41	Issue Type +	En	Location *	LS
Category	Supplemental			GPS Latitude/Longitude	
				Start	End
Item	DWR UCIP Field Study			38.332039 °	38.332039 °
				-121.569730 °	-121.569730 °
DWR ID					
Comment Code					
Inspector Comment					
FS_ID:11705					
DS_ID:21982					
EP_NO: 2759					
Repair Type: Non-Urgent					
Crossing Status: Found					
UCIP Comments: Unclear where exact crossing is located.					
FIELD_STRUCT_DESC: 1-inch steel waterline through the levee.					
Ramp, boating facilities on waterward side (Courtland boating facilities).					
Pipe visible under buildings at concrete foundation on LS. Water					
service connections for irrigation located on WS slope. (Permit No.					
2759, 1959)					
FS Date: 4/10/2013

Irrigation pipes on WS slope.

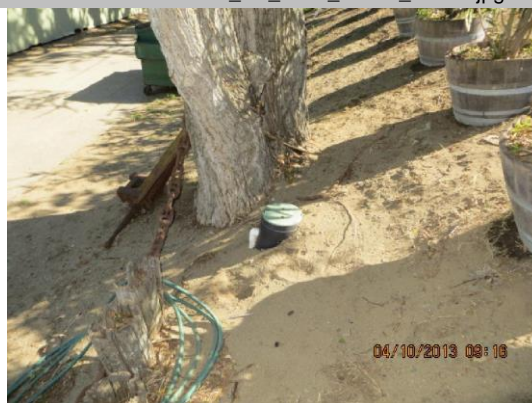
Photo 2 of 2 : UCIP_FA_2016_11705_19144.jpg

Irrigation pipes on WS slope.

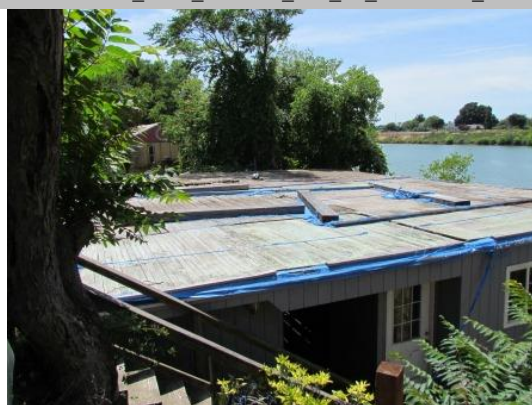
Photo 1 of 2 : FA_2016_RD0551_175_21_20161018_00001.jpg

LM Start	0.49	Rating **	M	Issue No.	21
LM End	0.49	Issue Type +	En	Location *	WS
Category	Earthen Levee			GPS Latitude/Longitude	
				Start	End
Item	Encroachments			38.331158 °	38.331158 °
				-121.570751 °	-121.570751 °
DWR ID	DWR_RD0551_01_s_2014_21				
Comment Code					
BU : Building					
Inspector Comment					
The new land owner is working with the LMA trying to get CVFPB Permits for this project, this is the 2nd year in process. This site is still being worked on.

Building remodeling project on waterside levee section. Photo taken 01-04-2014.

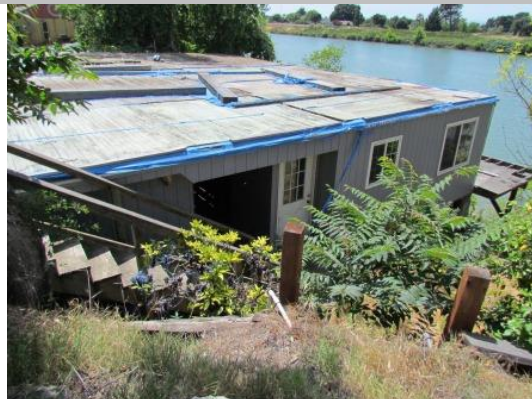
Photo 2 of 2 : FA_2016_RD0551_175_21_20161018_00002.jpg

LM Start	0.49	Rating **	M	Issue No.	21 (cont)	
LM End	0.49	Issue Type +	En	Location *	WS	
Category	Earthen Levee			GPS Latitude/Longitude		
				Start		End
Item	Encroachments			38.331158 °		38.331158 °
				-121.570751 °		-121.570751 °
DWR ID	DWR_RD0551_01_s _ 2014_21					
Comment Code						
BU : Building						
Inspector Comment						
The new land owner is working with the LMA trying to get CVFPB Permits for this project, this is the 2nd year in process. This site is still being worked on.

Building and steps waterward. Photo taken 01-04-2014.

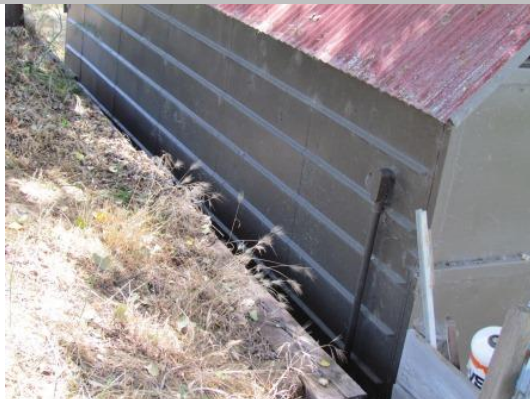
Photo 1 of 1 : FA_2016_RD0551_175_87_20161018_00005.jpg

LM Start	0.59	Rating **	A	Issue No.	87
LM End	0.59	Issue Type +	En	Location *	WS
Category	Earthen Levee			GPS Latitude/Longitude	
				Start	End
Item	Encroachments			38.329895 °	38.329895 °
				-121.571840 °	-121.571840 °
DWR ID	DWR_RD0551_01_s_2012_87				
Comment Code					
RW : Retaining Wall					
Inspector Comment					
Permit is in process.

This unauthorized retaining wall remains. Photo taken 01-04-2014. No photo taken during Fall 2014 inspection.

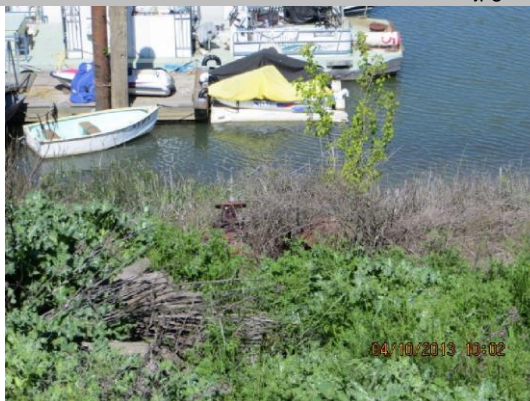
Photo 1 of 2 : UCIP_FA_2016_11726_19165.jpg

LM Start	0.71	Rating **	M	Issue No.	95
LM End	0.71	Issue Type +	En	Location *	WS
Category	Supplemental			GPS Latitude/Longitude	
				Start	End
Item	DWR UCIP Field Study			38.328401 °	38.328401 °
				-121.572954 °	-121.572954 °
DWR ID					
Comment Code					
Inspector Comment					
FS_ID:11726 DS_ID:21985 EP_NO: 6220 Repair Type: Non-Urgent Crossing Status: Found UCIP Comments: Pipe abandoned and should be removed. FIELD_STRUCT_DESC: 8-inch steel irrigation pipe through the levee 6.1-feet below the crown. Pump on waterside with slide gate and air vent. (Permit No. 6220, 1968) FS Date: 4/10/2013

Abandoned pump covered in vegetation on WS slope.

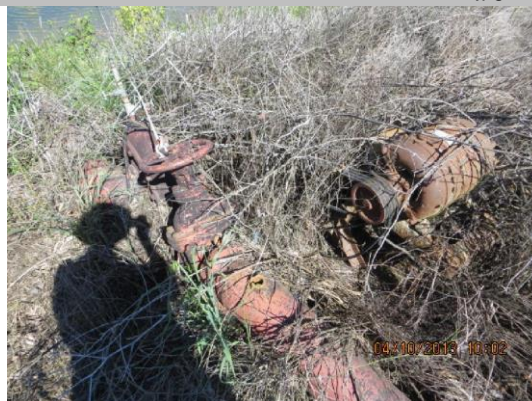
Photo 2 of 2 : UCIP_FA_2016_11726_19164.jpg

LM Start	0.71	Rating **	M	Issue No.	95 (cont)
LM End	0.71	Issue Type +	En	Location *	WS
Category	Supplemental			GPS Latitude/Longitude	
				Start	End
Item	DWR UCIP Field Study			38.328401 °	38.328401 °
				-121.572954 °	-121.572954 °
DWR ID					
Comment Code					
Inspector Comment					
FS_ID:11726 DS_ID:21985 EP_NO: 6220 Repair Type: Non-Urgent Crossing Status: Found UCIP Comments: Pipe abandoned and should be removed. FIELD_STRUCT_DESC: 8-inch steel irrigation pipe through the levee 6.1-feet below the crown. Pump on waterside with slide gate and air vent. (Permit No. 6220, 1968) FS Date: 4/10/2013

Pump, slide gate, and missing vent pipe on WS slope.

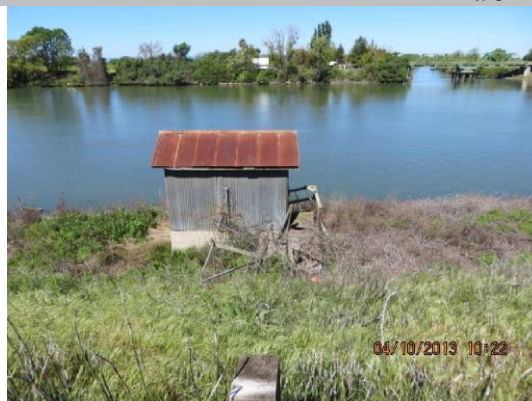
Photo 1 of 2 : UCIP_FA_2016_11727_19168.jpg

LM Start	0.89	Rating **	M	Issue No.	96
LM End	0.89	Issue Type +	En	Location *	LS
Category	Supplemental			GPS Latitude/Longitude	
				Start	End
Item	DWR UCIP Field Study			38.326088 °	38.326088 °
				-121.574525 °	-121.574525 °
DWR ID					
Comment Code					
Inspector Comment					
FS_ID:11727 DS_ID:21986 EP_NO: 701 Repair Type: Non-Urgent Crossing Status: Found UCIP Comments: Pipe appears abandoned and should be done so properly. Good candidate for video inspection. FIELD_STRUCT_DESC: 14-inch steel irrigation pipe through the levee, 7.2 feet below crown. Pump in pump house on waterward slope. Service pole on landward slope. (Permit No. 701-Smith). 1-inch galvanized filler pipe and a 2-inch electrical conduit at same location. Originally included in O+M manual (1959). FS Date: 4/10/2013

Pump house and pipes visible on WS slope.

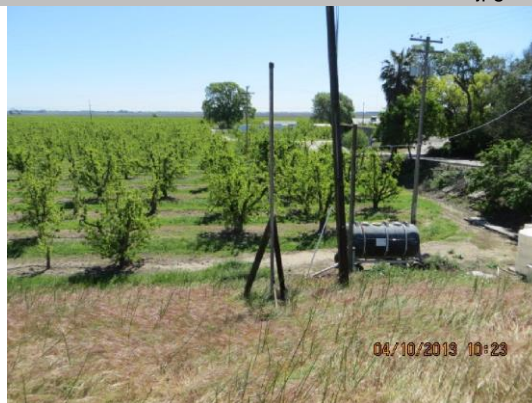
Photo 2 of 2 : UCIP_FA_2016_11727_19167.jpg

Pipe and JP visible on LS toe.

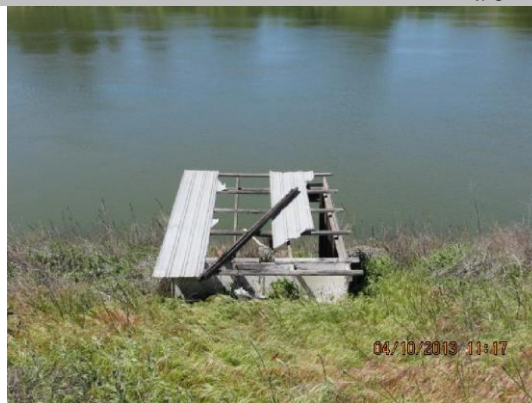
Photo 1 of 2 : UCIP_FA_2016_26874_49596.jpg

Comment Code					
Inspector Comment					
FS_ID:26874 DS_ID:21990 EP_NO: 11145 Repair Type: Non-Urgent Crossing Status: Found UCIP Comments: Based on District notes from January 14, 2014, pump discharge pipe has been repaired. Pipe failing on LS slope causing erosion along pipe alignment. Pipe debris on both slopes should be removed as well.: As of 12/13/2013 District President noted that the landowner had made repairs to the LS slope leaks.: As of 12/17/2013 District submitted letter to landowner explaining UCIP report details including photos of the pipe problems FIELD_STRUCT_DESC: 10-inch pipe through levee, 4.7 feet below crown. Pump in 7'X9' concrete pump house on waterward slope. 36-inch concrete riser on LS toe. 1-inch electrical conduit at same location. Service pole at landward toe (ABO No. 11145-Towne). Originally included in O+M manual (1959). FS Date: 1/15/2014

Pumphouse on WS slope.

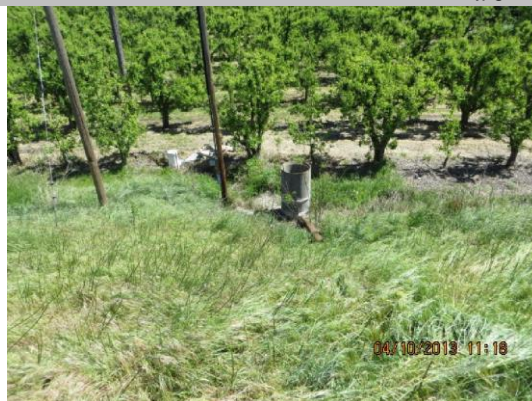
Photo 2 of 2 : UCIP_FA_2016_26874_49595.jpg

Comment Code					
Inspector Comment					
FS_ID:26874 DS_ID:21990 EP_NO: 11145 Repair Type: Non-Urgent Crossing Status: Found UCIP Comments: Based on District notes from January 14, 2014, pump discharge pipe has been repaired. Pipe failing on LS slope causing erosion along pipe alignment. Pipe debris on both slopes should be removed as well.: As of 12/13/2013 District President noted that the landowner had made repairs to the LS slope leaks.: As of 12/17/2013 District submitted letter to landowner explaining UCIP report details including photos of the pipe problems FIELD_STRUCT_DESC: 10-inch pipe through levee, 4.7 feet below crown. Pump in 7'X9' concrete pump house on waterward slope. 36-inch concrete riser on LS toe. 1-inch electrical conduit at same location. Service pole at landward toe (ABO No. 11145-Towne). Originally included in O+M manual (1959). FS Date: 1/15/2014

36-inch concrete standpipe at LS toe.

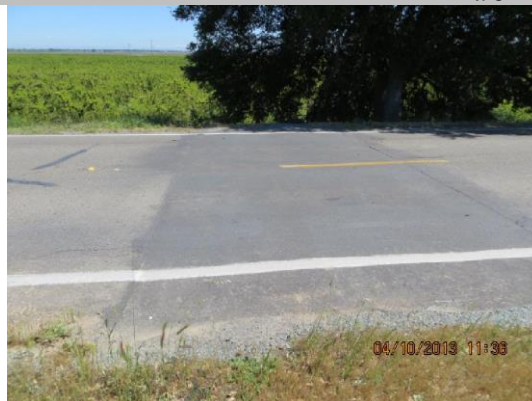
Photo 1 of 1 : UCIP_FA_2016_11749_19217.jpg

LM Start	2.01	Rating **	M	Issue No.	97
LM End	2.01	Issue Type +	En	Location *	WS
Category	Supplemental			GPS Latitude/Longitude	
				Start	End
Item	DWR UCIP Field Study			38.310237 °	38.310237 °
				-121.575470 °	-121.575470 °
DWR ID					
Comment Code					
Inspector Comment					
FS_ID:11749					
DS_ID:22040					
EP_NO: 3676					
Repair Type: Non-Urgent					
Crossing Status: Not Found					
UCIP Comments: Fresh cut through pavement on crown indicates recent work on pipes at this location. Need to determine if pipe was removed or abandoned in place.					
FIELD_STRUCT_DESC: 2 of 2: 8-inch steel irrigation pipe sleeved through a 12-inch pipe, 5 feet below crown. Pump on platform waterside. (Permit No. 3676-Wheeler).					
FS Date: 4/10/2013

Fresh cut through pavement at crown.

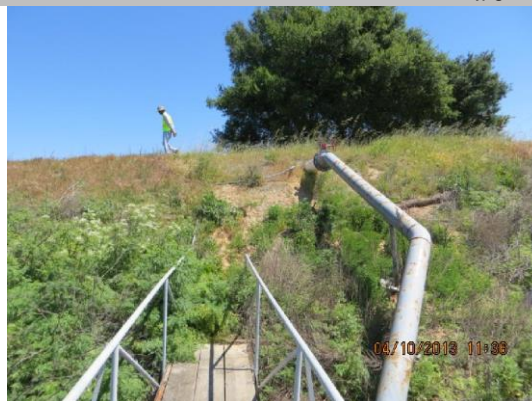
Photo 1 of 2 : UCIP_FA_2016_11763_19222.jpg

LM Start	2.01	Rating **	M	Issue No.	88
LM End	2.01	Issue Type +	En	Location *	WS
Category	Supplemental			GPS Latitude/Longitude	
				Start	End
Item	DWR UCIP Field Study			38.310223 °	38.310223 °
				-121.575458 °	-121.575458 °
DWR ID					
Comment Code					
Inspector Comment					
FS_ID:11763					
DS_ID:21991					
EP_NO: 6551					
Repair Type: Non-Urgent					
Crossing Status: Found					
UCIP Comments: Rodent activity undermining pipe on LS slope.					
FIELD_STRUCT_DESC: 1 of 2: 14-inch PVC wrapped Steel irrigation					
pipe 3-feet below the crown. Butterfly valve on WS shoulder. 2-inch					
galvanized electric conduit at same location. Pump on pile structure on					
WS toe. Pressure booster and pump on LS toe. (Permit No. 6551-					
Wheeler 1969).					
FS Date: 4/10/2013

Pipe, butterfly vavle, and electrical conduit 3-feet below the crown on the WS shoulder.

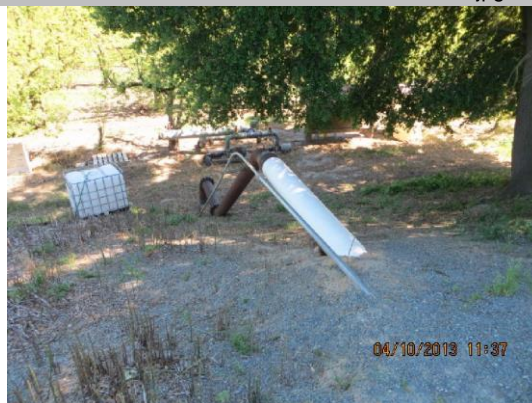
Photo 2 of 2 : UCIP_FA_2016_11763_19221.jpg

Pipe, electrical conduit, and booster pump on LS toe.

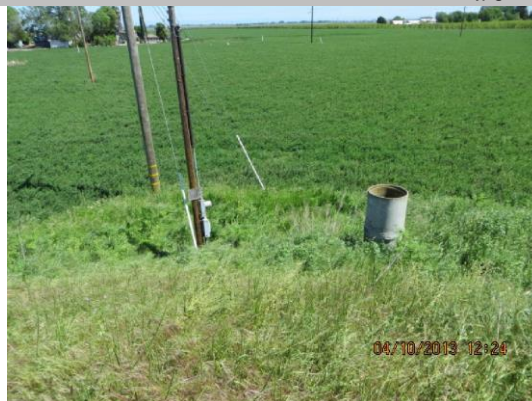
Photo 1 of 2 : UCIP_FA_2016_11783_19241.jpg

LM Start	2.41	Rating **	M	Issue No.	89
LM End	2.41	Issue Type +	En	Location *	WS
Category	Supplemental			GPS Latitude/Longitude	
				Start	End
Item	DWR UCIP Field Study			38.305189 °	38.305189 °
				-121.572012 °	-121.572012 °
DWR ID					
Comment Code					
Inspector Comment					
FS_ID:11783 DS_ID:21994 EP_NO: 11141 Repair Type: Non-Urgent Crossing Status: Found UCIP Comments: Records indicate this pipe was abandoned, but it appears to be active. Verify status. FIELD_STRUCT_DESC: 10-inch steel irrigation pipe through levee, 8.0 feet below the crown. Slant pump on waterward slope. Service pole on landward slope with a 1.5-inch galvanized iron electrical conduit through the levee at same location. (ABO No. 11141-Runyon). Originally included in O+M manual (1959). FS Date: 4/10/2013

JP and concrete standpipe on LS toe.

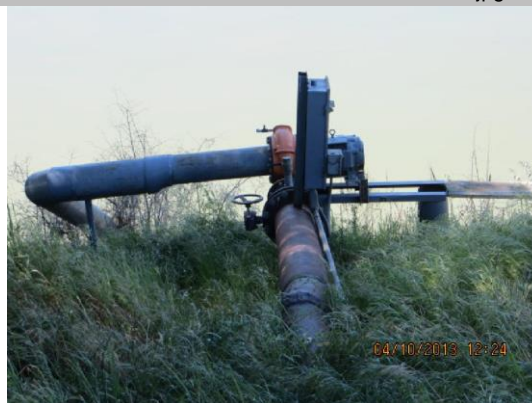
Photo 2 of 2 : UCIP_FA_2016_11783_19240.jpg

Pump, pipe, and butterfly valve on WS slope.

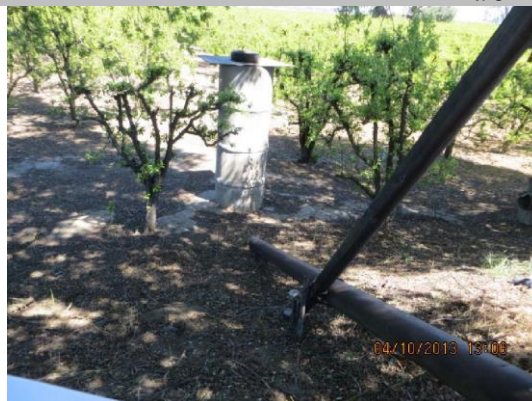
Photo 1 of 2 : UCIP_FA_2016_11803_19261.jpg

LM Start	2.96	Rating **	M	Issue No.	90
LM End	2.96	Issue Type +	En	Location *	WS
Category	Supplemental			GPS Latitude/Longitude	
				Start	End
Item	DWR UCIP Field Study			38.298323 °	38.298323 °
				-121.566941 °	-121.566941 °
DWR ID					
Comment Code					
Inspector Comment					
FS_ID:11803					
DS_ID:22032					
EP_NO: 1204					
Repair Type: Non-Urgent					
Crossing Status: Found					
UCIP Comments: Gap between sleeved pipes does not appear to be grouted on LS slope.					
FIELD_STRUCT_DESC: 12-inch steel conduit with 10-inch irrigation pipe sleeved through it 6-feet below the crown. Pump on pile structure on the Water Side toe. 48-inch concrete riser on LS toe. (Permit No. 1204-Wheeler). Originally included in the O+M manual 1959.					
FS Date: 4/10/2013

48-inch concrete riser on LS toe.

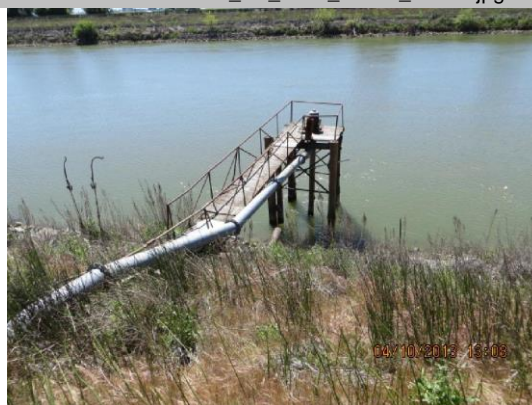
Photo 2 of 2 : UCIP_FA_2016_11803_19260.jpg

10-inch steel irrigation pipe and steel pump structure on WS toe.

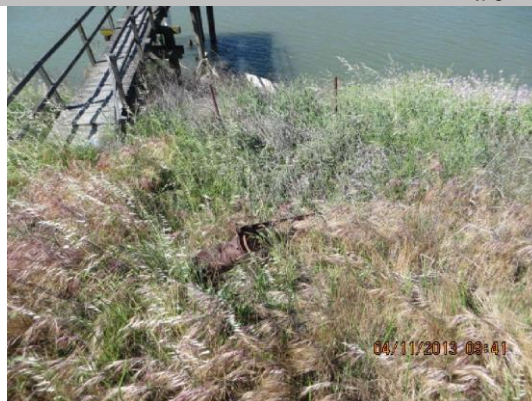
Photo 1 of 2 : UCIP_FA_2016_11817_19287.jpg

LM Start	4.01	Rating **	M	Issue No.	92
LM End	4.01	Issue Type +	En	Location *	WS
Category	Supplemental			GPS Latitude/Longitude	
				Start	End
Item	DWR UCIP Field Study			38.286593 °	38.286593 °
				-121.554591 °	-121.554591 °
DWR ID					
Comment Code					
Inspector Comment					
FS_ID:11817					
DS_ID:22034					
EP_NO: N/A					
Repair Type: Non-Urgent					
Crossing Status: Found					
UCIP Comments: Abandoned. Determine if pipe was removed or abandoned in place.					
FIELD_STRUCT_DESC: 8-inch irrigation pipe through the levee 6.7-feet below the crown. Abandoned slide gate at pad on WS slope.					
Originally included in O+M manual 1959.					
FS Date: 4/11/2013

Abandoned slide gate on WS slope.

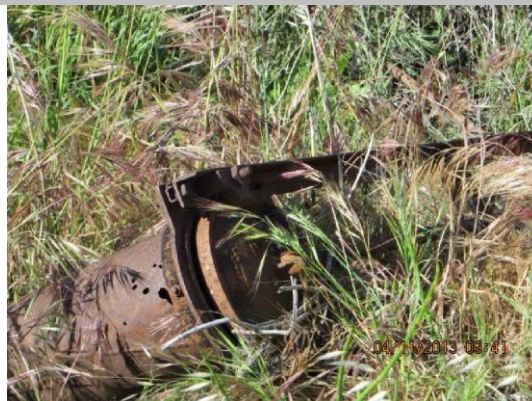
Photo 2 of 2 : UCIP_FA_2016_11817_19286.jpg

Abandoned slide gate on WS slope.

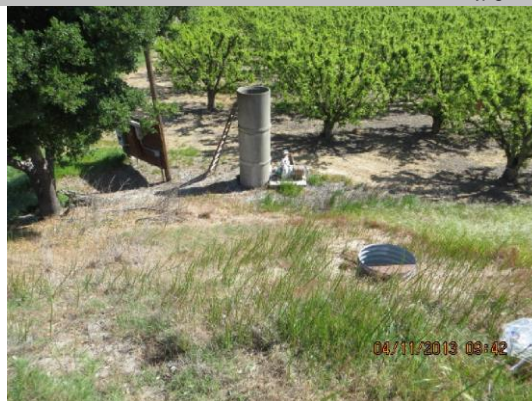
Photo 1 of 2 : UCIP_FA_2016_11823_19301.jpg

LM Start	4.02	Rating **	M	Issue No.	93
LM End	4.02	Issue Type +	En	Location *	WS
Category	Supplemental			GPS Latitude/Longitude	
				Start	End
Item	DWR UCIP Field Study			38.286568 °	38.286568 °
				-121.554569 °	-121.554569 °
DWR ID					
Comment Code					
Inspector Comment					
FS_ID:11823 DS_ID:22018 EP_NO: 11146 Repair Type: Non-Urgent Crossing Status: Found UCIP Comments: Wooden walkway in bad repair and presents a hazard to the public. FIELD_STRUCT_DESC: 14-inch pipe through levee, 10.4 feet below crown. Pump on pile structure in stream with wooden walkway. 48-inch concrete standpipe on LS toe with booster pump and electric panel. Siphon breaker in 24-inch CMP riser on LS slope. 1.5-inch electrical conduit at same location.(ABO No. 11146- Turner). Originally included in O+M manual 1959. FS Date: 4/11/2013

24-inch CMP riser and 48-inch concrete riser on LS slope.

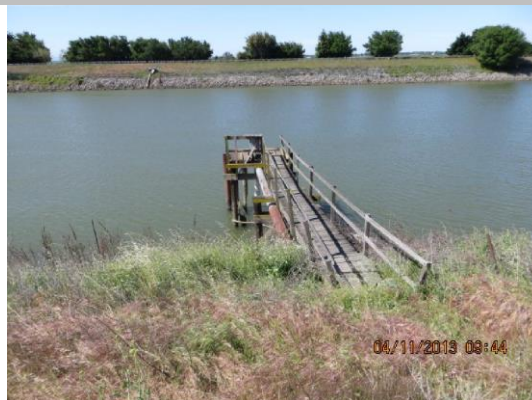
Photo 2 of 2 : UCIP_FA_2016_11823_19300.jpg

Pump on pier with wooden walkway on WS toe.

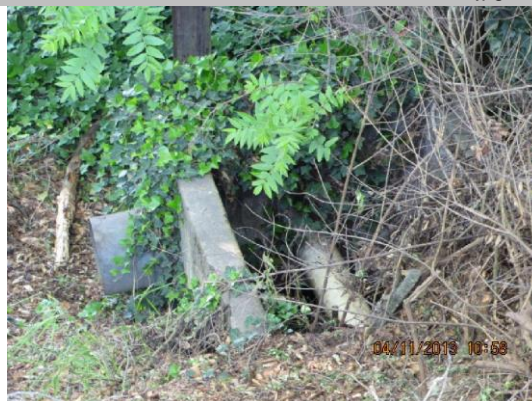
Photo 1 of 2 : UCIP_FA_2016_12105_19649.jpg

LM Start	5.05	Rating **	M	Issue No.	91
LM End	5.05	Issue Type +	En	Location *	WS
Category	Supplemental			GPS Latitude/Longitude	
				Start	End
Item	DWR UCIP Field Study			38.276220 °	38.276220 °
				-121.540811 °	-121.540811 °
DWR ID					
Comment Code					
Inspector Comment					
FS_ID:12105 DS_ID:22022 EP_NO: 11125 Repair Type: Non-Urgent Crossing Status: Found UCIP Comments: Pumphouse has been removed from pump and pump is in disrepair. Pipe at LS toe is sleeved or has been replaced with a 6-inch PVC pipe. This pump appears abandoned and should be done so properly. FIELD_STRUCT_DESC: 6-inch pipe through the levee 6.5-feet below the crown. Pump and slide gate on WS slope. 1-inch electrical conduit at same location with service pole at landward toe. 4'X6' concrete distribution box at LS toe (ABO No. 11125- Cortopassi). Originally included in O+M manual 1959. FS Date: 4/11/2013

Pipe in distribution box at LS toe.

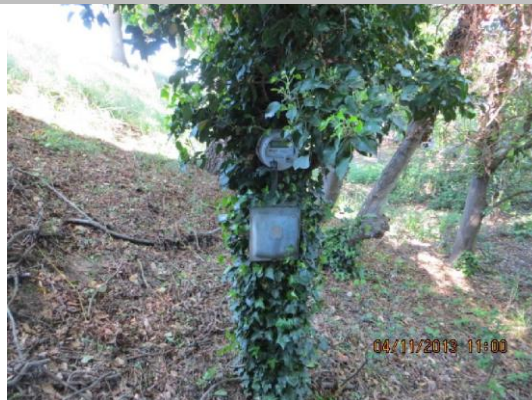
Photo 2 of 2 : UCIP_FA_2016_12105_19648.jpg

Meter on pole at LS toe.

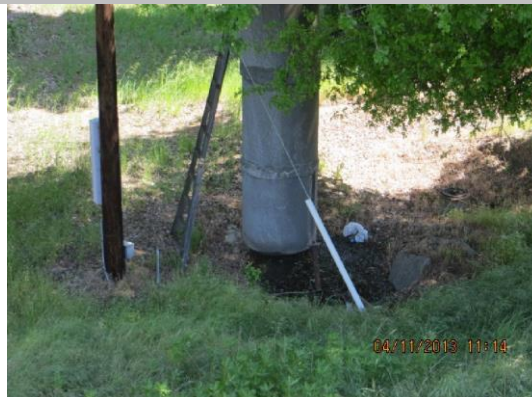
Photo 1 of 2 : UCIP_FA_2016_26875_49602.jpg

FS_ID:26875
DS_ID:22023
EP_NO: 11131
Repair Type: Non-Urgent
Crossing Status: Found
UCIP Comments: Based on District notes from January 15, 2014, pump discharge pipe has been repaired. Corrosion holes in pipe at LS toe good indicator that pipe is failing internally. Pipe should be examined internally for damage (video inspect).: As of 12/12/2013 the District discussed with farmer tenant what needed to be done, and the tenant informed the District that they would address the repairs.: As of 12/17/2013 District submitted letter to landowner explaining UCIP report details including photos of the pipe problems
FIELD_STRUCT_DESC: 10-inch pipe through the levee 7.7-feet below the crown. Pump and slide gate on concrete pad on waterward slope. Siphon breaker in 24-inch CMP riser on LS slope. Concrete riser, power pole with panel box on landward toe. (ABO No. 11131-Latimer). Originally included in the O+M manual 1959.

Concrete standpipe, JP and meter, and 4-inch steel pipe visible at LS toe.

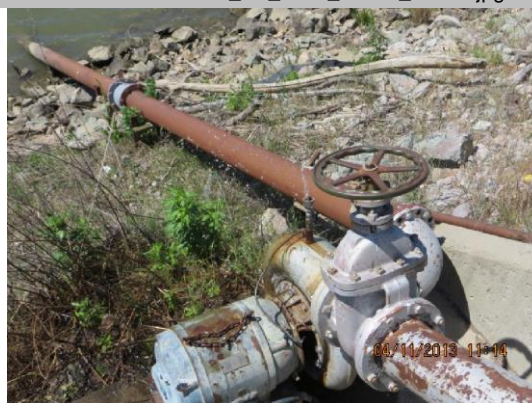
Photo 2 of 2 : UCIP_FA_2016_26875_49601.jpg

Pump and slide gate at Concrete pad on WS slope.
